Faecal pollution and solar purification of community water sources within Lake Naivasha basin, Kenya

ARTICLE *in* JOURNAL OF WATER, SANITATION AND HYGIENE FOR DEVELOPMENT · JUNE 2015

Impact Factor: 0.44 · DOI: 10.2166/washdev.2015.150

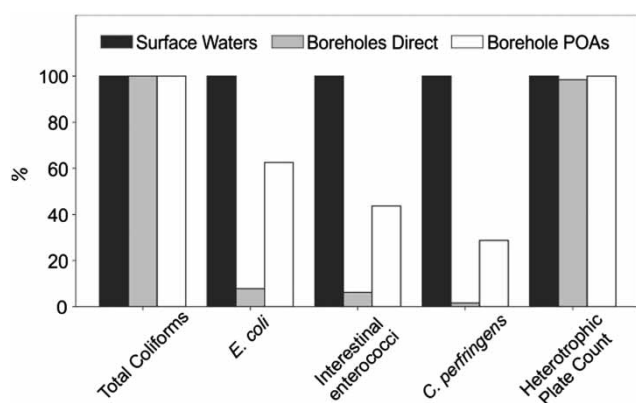
Figure 4 | The percentage of samples from different sources with microbiological densities above the recommended drinking water quality guidelines.

Only total coliforms within the POA sites and the HPC within both the direct borehole and POA sites were significantly different. On a general note, surface water sources had the highest percentage contamination followed by borehole POA while borehole direct had the lowest (Figure 4). Based on drinking water quality standards set by various agencies (Table 1), the samples collected from the direct borehole sites had *E. coli*, intestinal enterococci and *C. perfringens* values that were within the recommended water quality standards while total coliforms and HPC values were above the recommended standards. Within the borehole POA sources, all the microbiological parameters were above the recommended drinking water quality standards and the microbiological parameters of samples collected from the surface sources were much higher than the recommended drinking water quality standards.
